DOCUMENTO N° 1: MEMORIA Y ANEJOS

ANEJO 06: ESTUDIO HIDROLÓGICO – HIDRÁULICO DE LA RAMBLA DEL RAMONETE

**PROYECTO DE LA ESTACIÓN DEPURADORA DE AGUAS
RESIDUALES DE RAMONETE, T.M. DE LORCA (MURCIA)**

CONSEJERÍA DE AGRICULTURA Y AGUA DE LA COMUNIDAD AUTÓNOMA DE LA
REGIÓN DE MURCIA

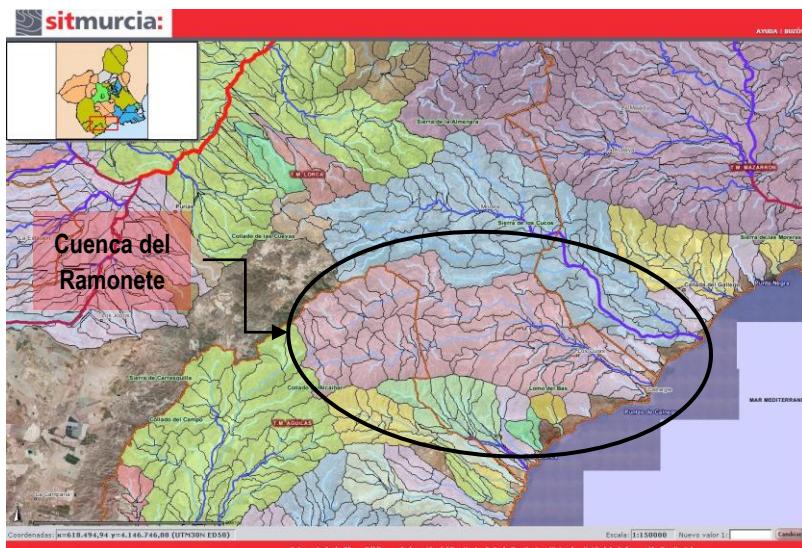
Figura 1. Ubicación de la cuenca de la Rambla del Ramonete. (Fuente: SITMurcia)

La rambla objeto de estudio, Ramonete, cuenta con una superficie de 69,67 km² que se alarga en dirección Noroeste-Sureste siguiendo la disposición de arcos concéntricos que configuran los relieves de la Sierra de Almenara, al Norte, y del Lomo de Bas, al sur, de forma que, desde su extremo occidental, ésta se curva ligeramente hasta el litoral.

Como puede apreciarse en la figura número 1, la zona de estudio se localiza en la cuenca de la rambla del Ramonete, según se ha extraído del Sistema de Información Territorial de la Región de Murcia (SITMURCIA) y del mapa topográfico nacional 975-IV y 976-III.

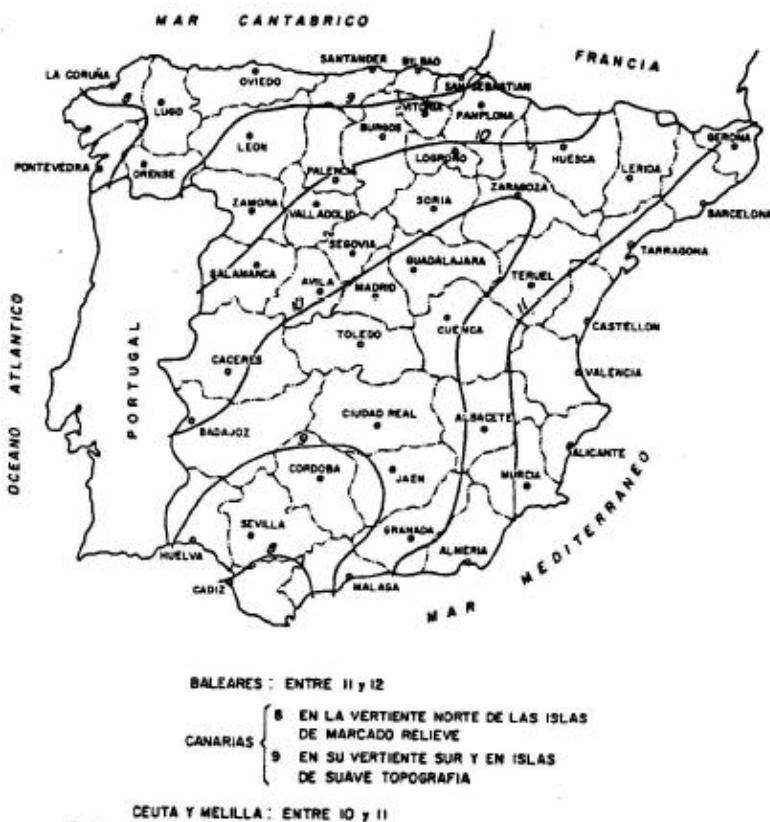
Figura 3. Estimación de I_1/I_d . (Fuente: Instrucción 5.2 –IC. Figura 2.2)

De la figura anterior se obtiene el valor de I_1/I_d de 11. De modo que los valores de I_t para los distintos períodos de retorno son:

I₁ (mm/h): Intensidad horaria de precipitación correspondiente al período de retorno considerado. El valor de la razón I₁/I_d se obtiene de la figura 2.2 de la Instrucción de Carreteras 5.2 IC.

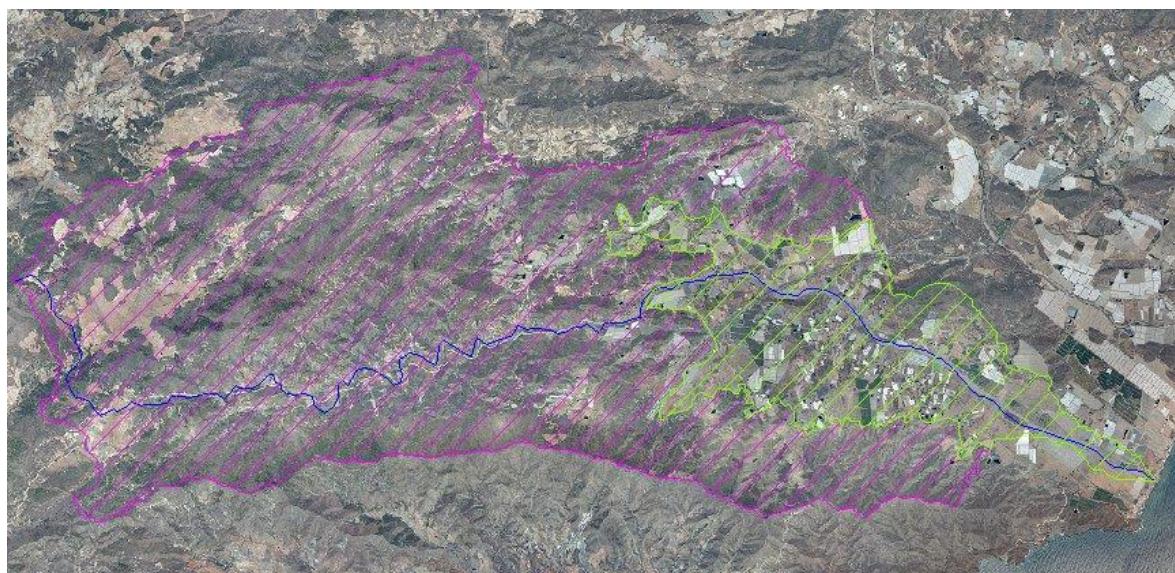
Figura 4. Usos del suelo de la cuenca.

En el caso de la cuenca objeto de estudio, se estima que el uso de los terrenos está dividido en dos tipos: uno de ellos corresponde a masa forestal (densidad clara), rayado en magenta en la siguiente figura, y el otro, en el extremo sureste de la cuenca, a cultivos en hilera en los que no se hace diferencia entre el laboreo en línea recta (R) y el laboreo en línea de nivel (N), por carecer de sentido al tratarse de terrenos con muy poca pendiente (2,2 %), rayado en verde.

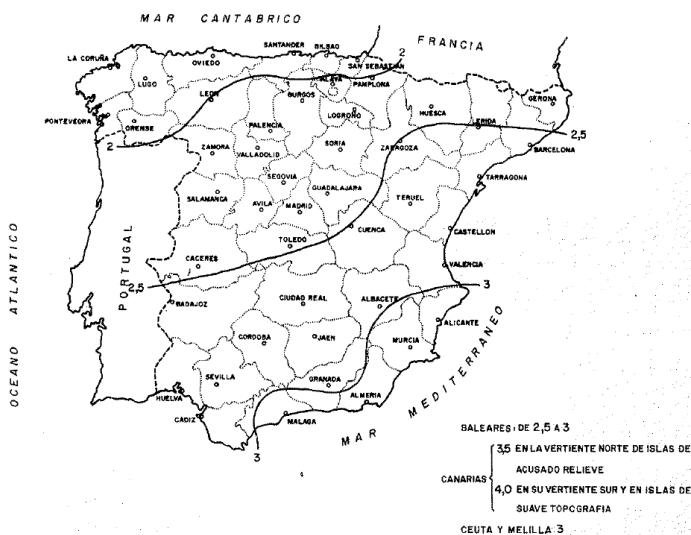
Figura 6. Mapa del coeficiente corrector del umbral de escorrentía. (Fuente: Instrucción 5.2 – IC. Figura 2.5)

El valor del coeficiente corrector para la zona de Murcia donde nos encontramos corresponde a 3,2.

Finalmente, al valor de P_0 se le aplica un factor corrector que considera la variación regional de la humedad del suelo al comienzo de aguaceros significativos. Este factor intenta evitar el sobredimensionamiento del caudal. (Corresponde a la Fig. 2.5 de la Instrucción 5.2 IC).

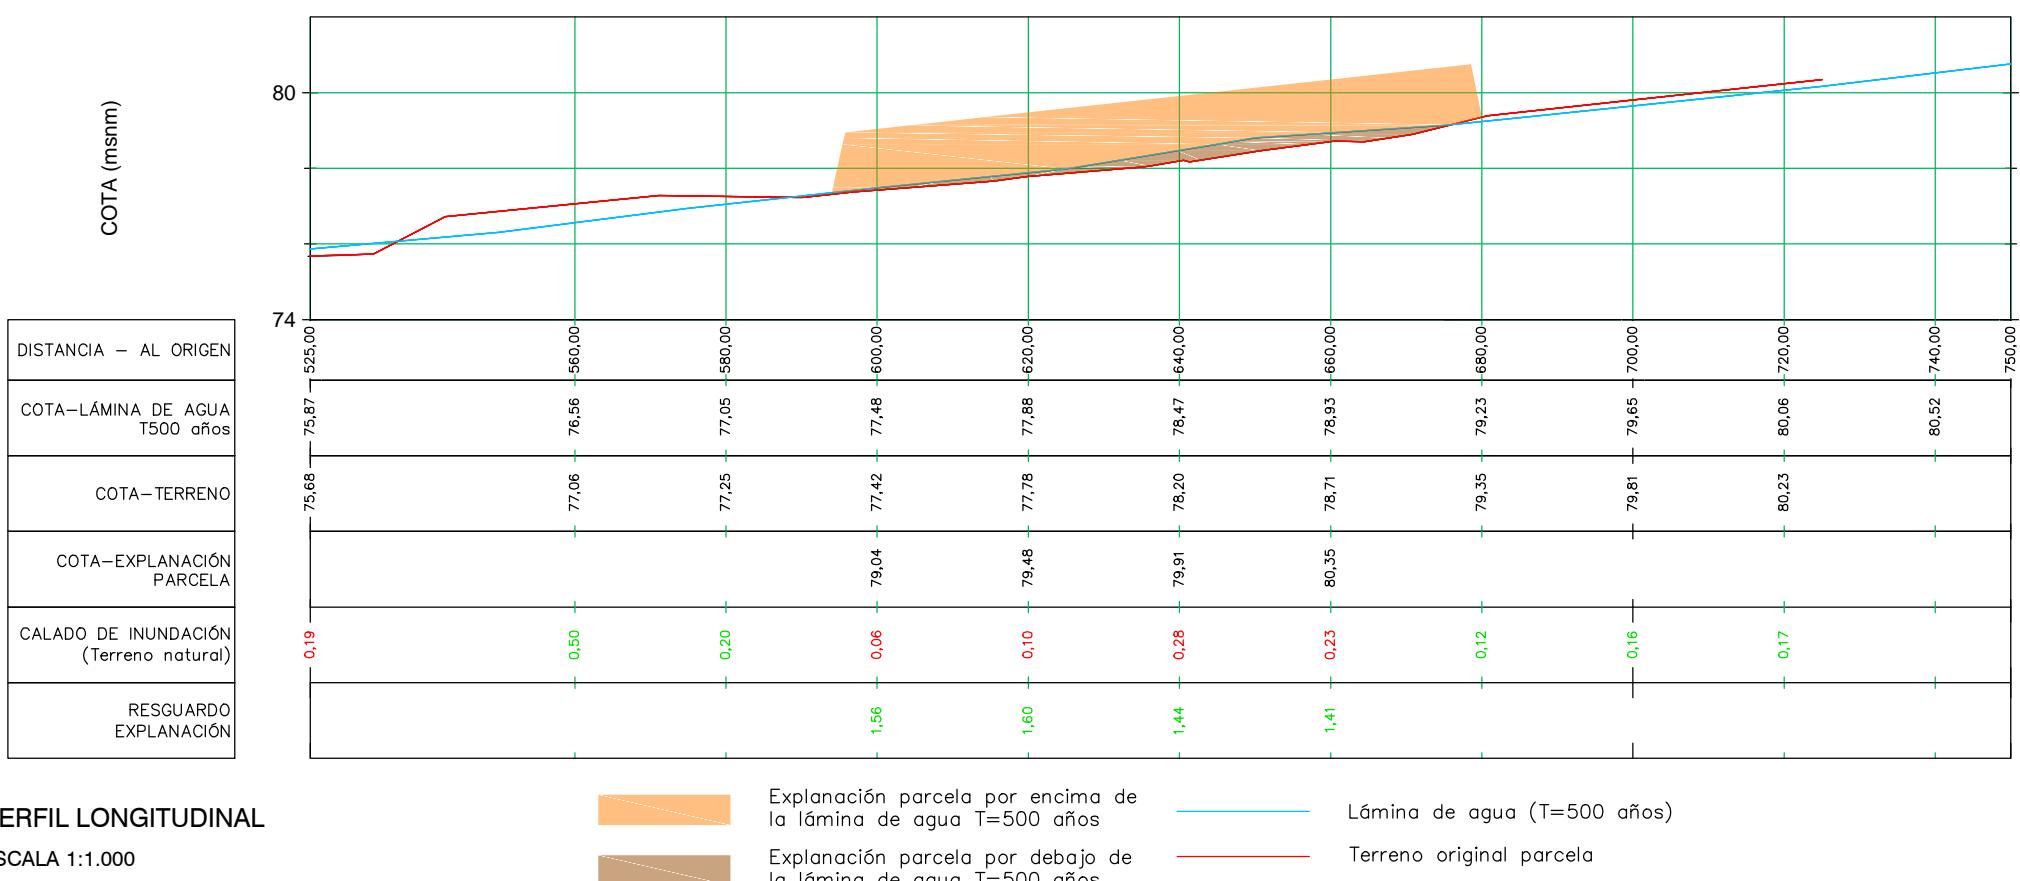
Perfil Longitudinal: ZONA ACTUACIÓN
Escalas - V: 200 H:1000

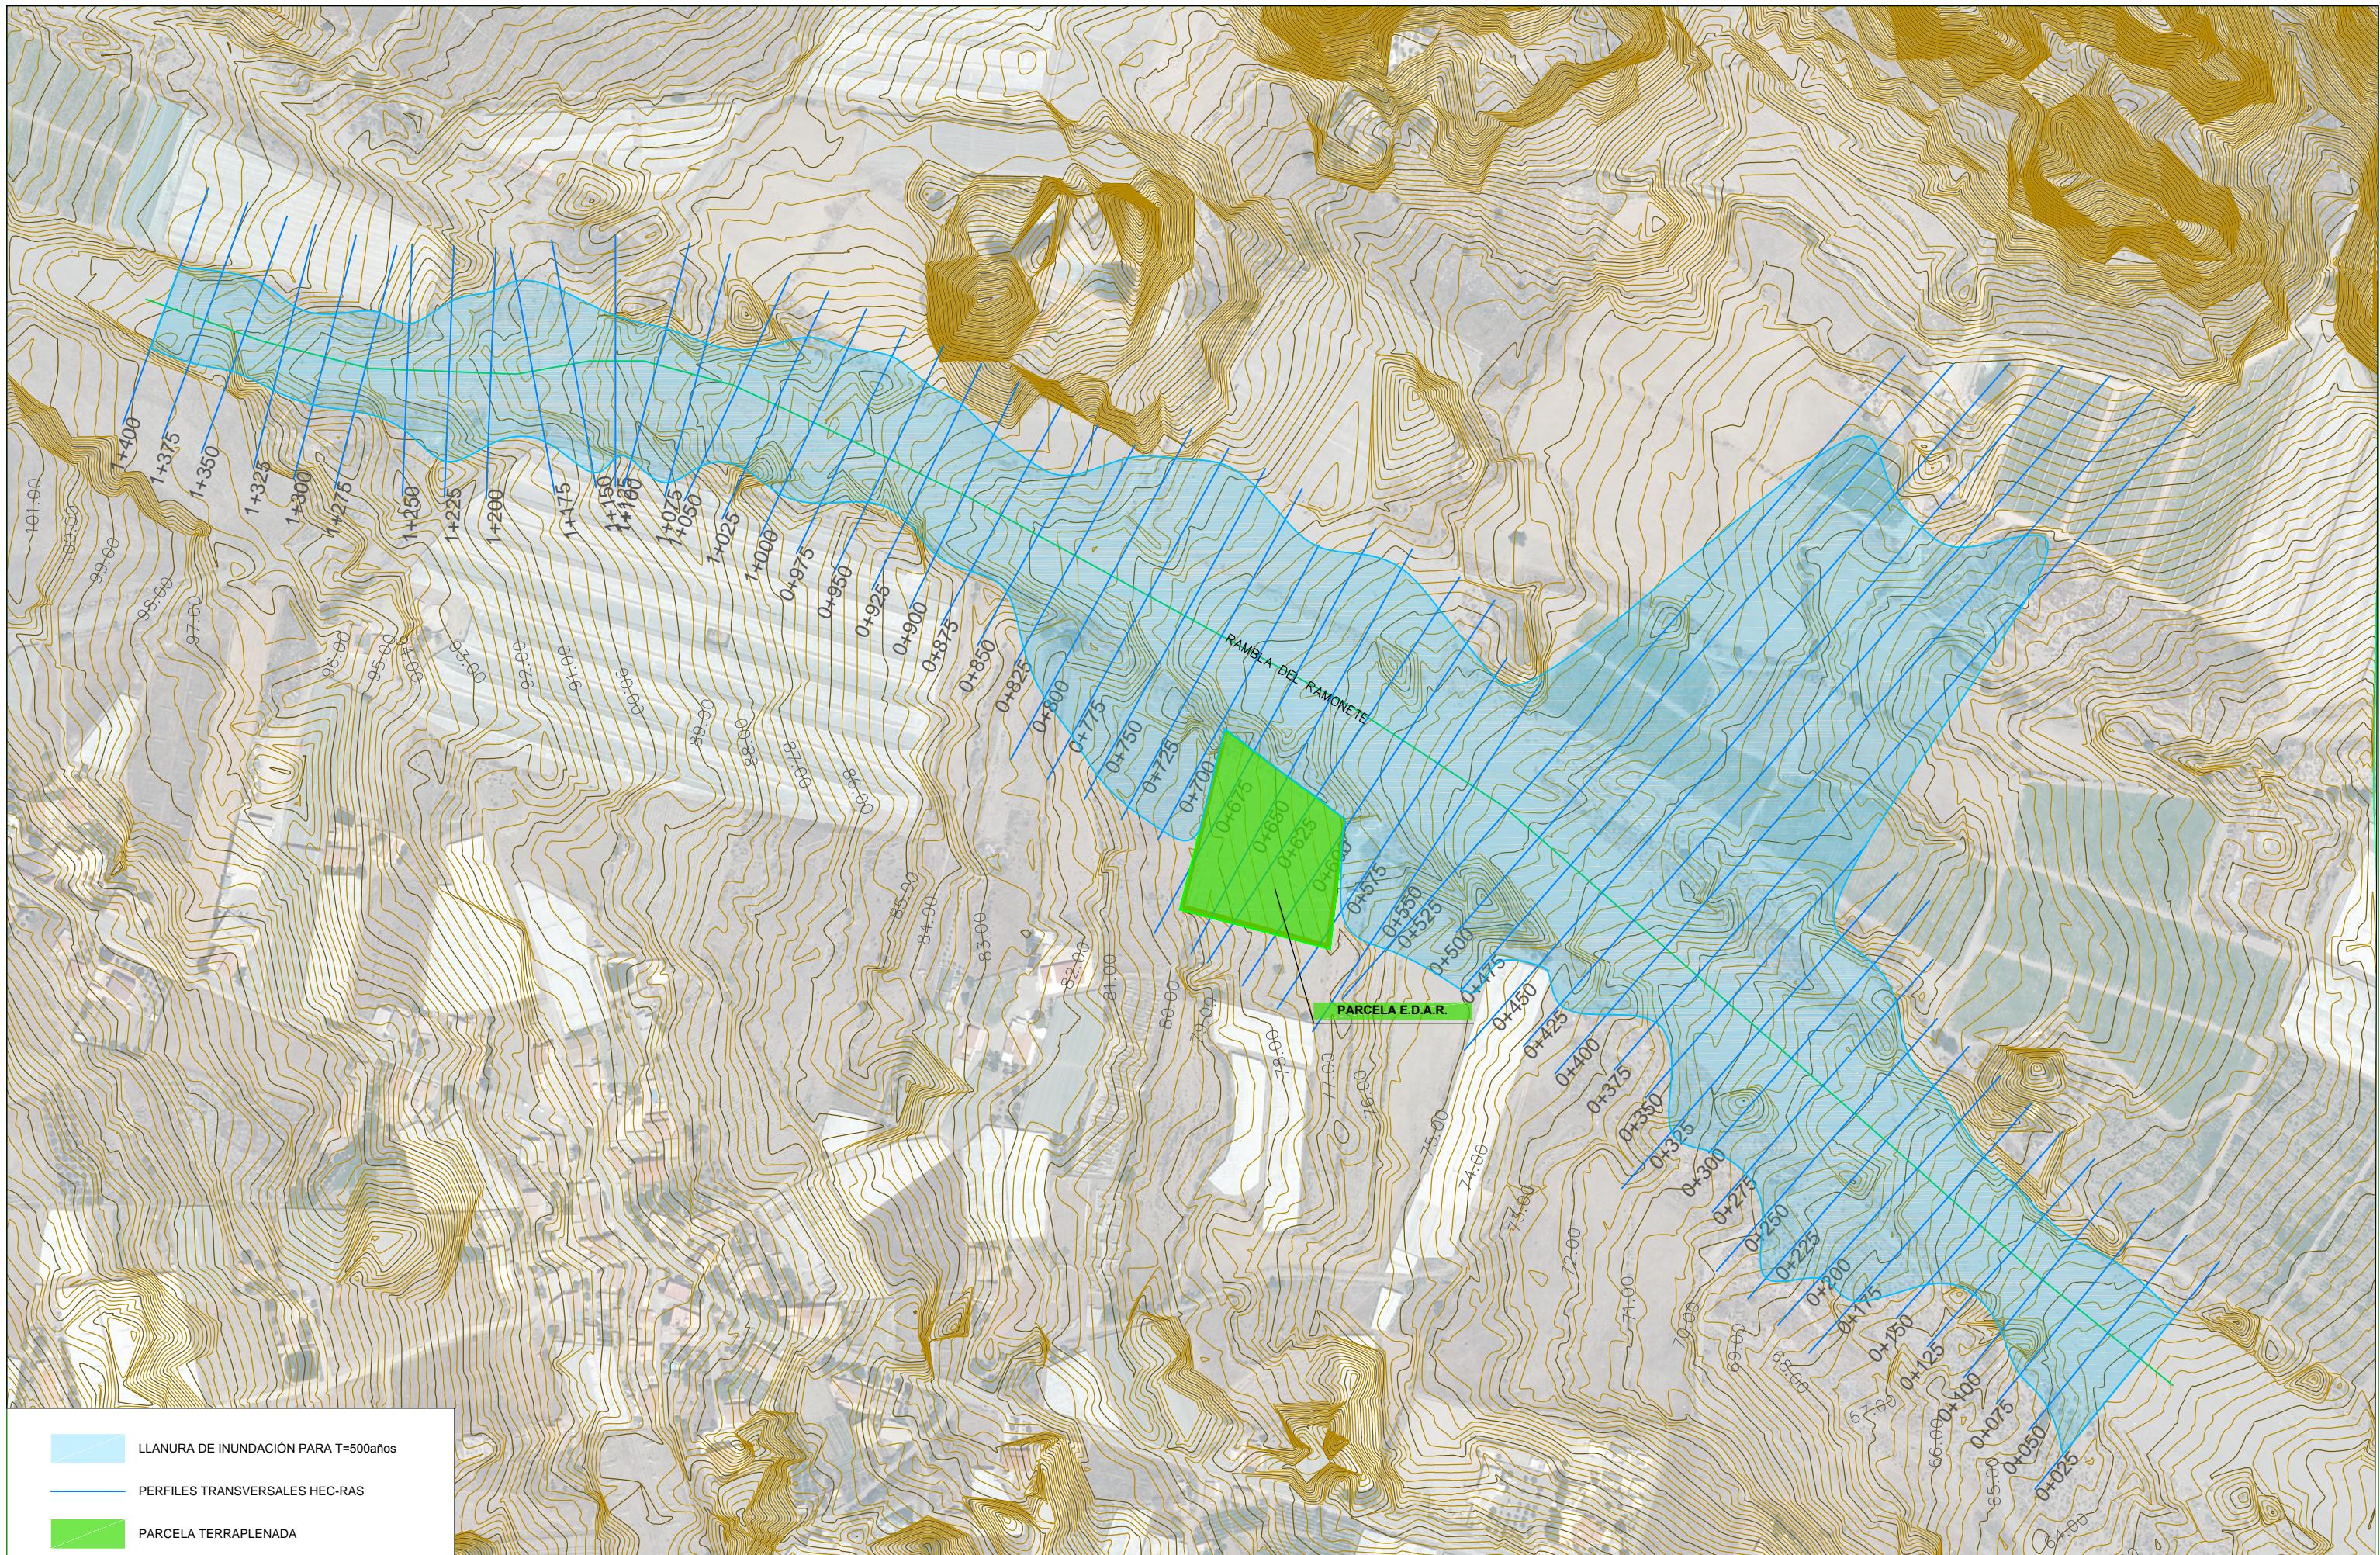
Región de Murcia Consejería de Agricultura y Agua Dirección General del Agua	INGENIERO DIRECTOR DE PROYECTO Fdo. Francisco Lucas Martínez	INGENIERO AUTOR DEL PROYECTO Fdo. Miguel Ángel Gimeno Martínez	ASISTENCIA TÉCNICA 	ESCALA 1/3.500	TÍTULO	PROYECTO DE LA ESTACIÓN DEPURADORA DE AGUAS RESIDUALES DE RAMONETE, TM DE LORCA (MURCIA)		PLANO N°	ANEJO 06
						FECHA FEBRERO 2014	PLANO LLANURA DE INUNDACIÓN		
								HOJA	04 DE 04

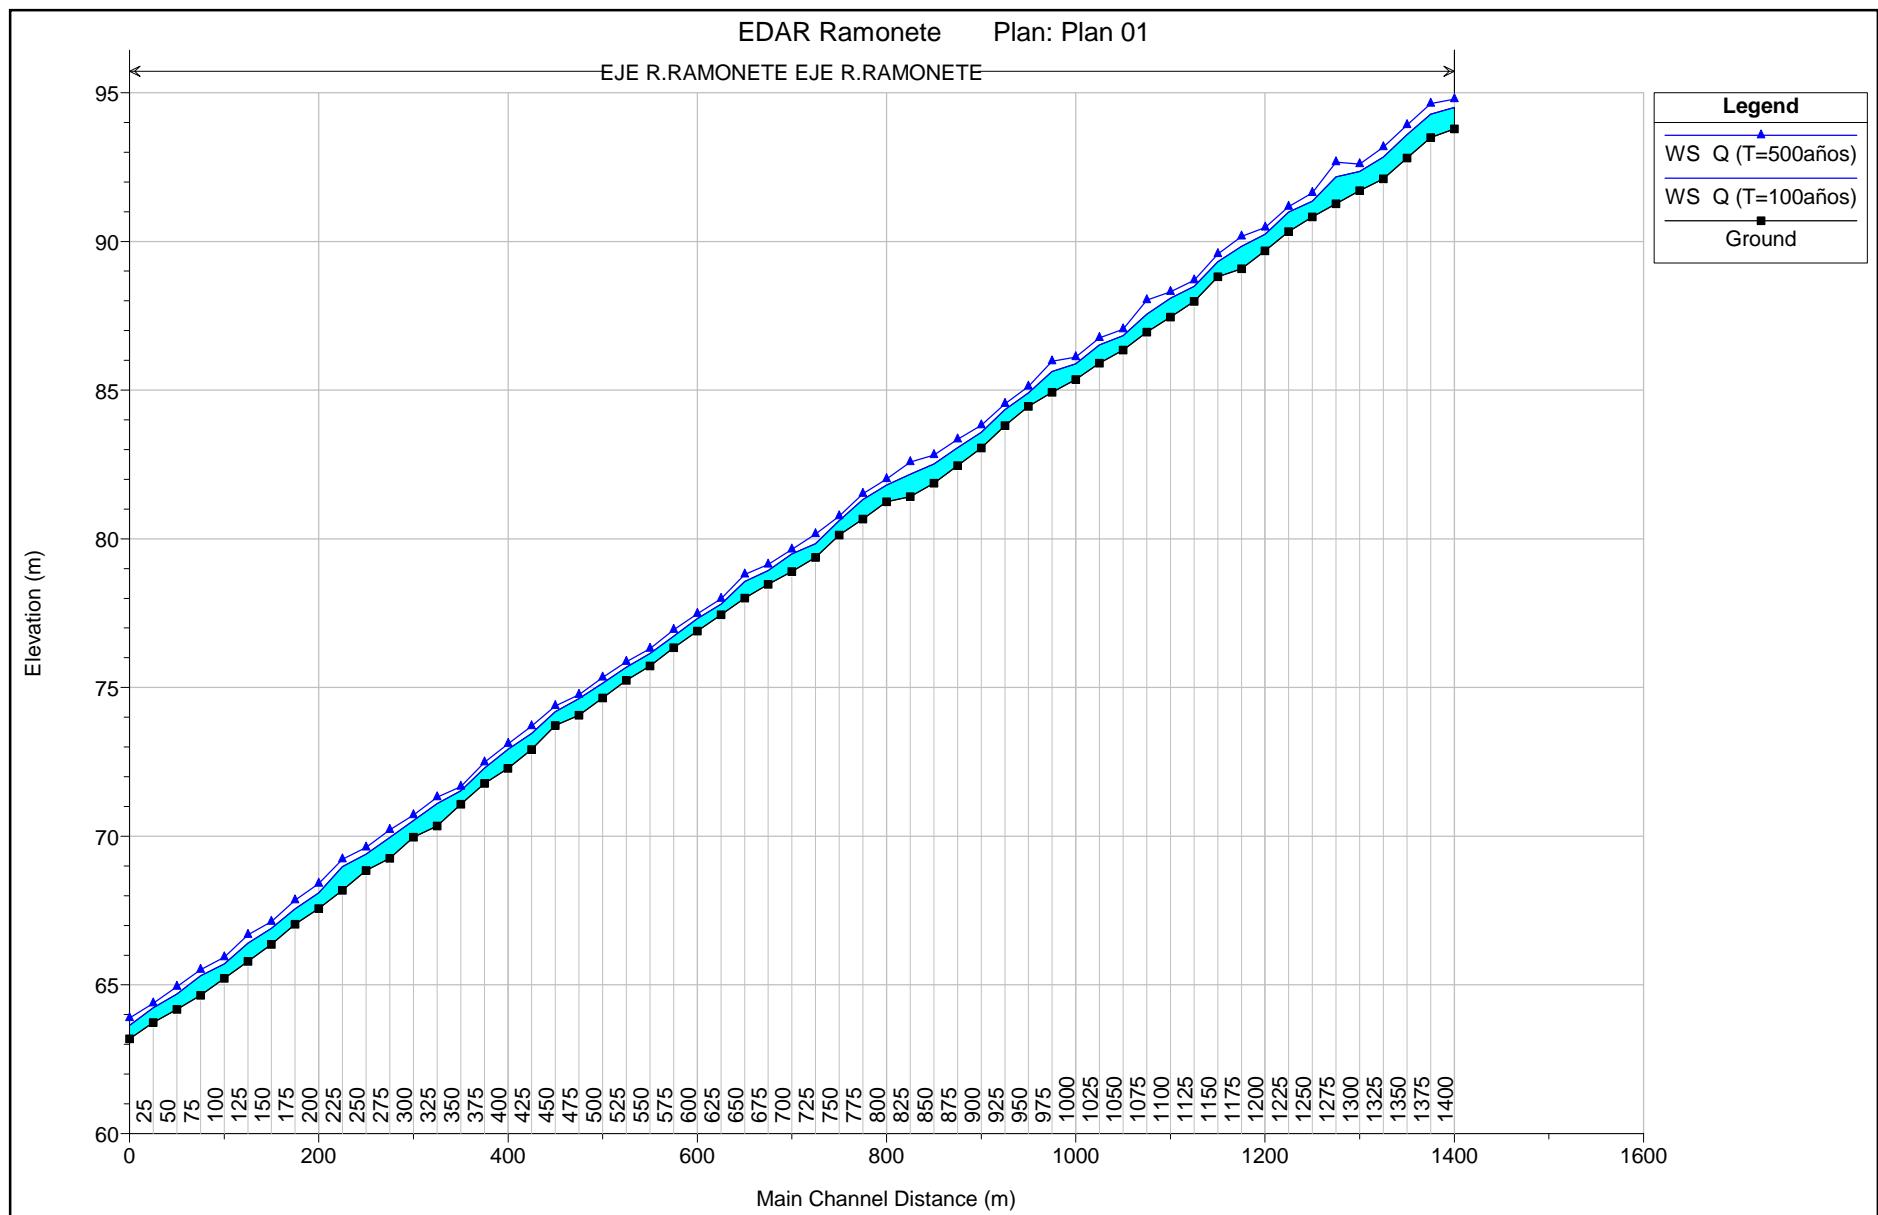
EDAR Ramonete Plan: Plan 01

Legend	
WS Q (T=100años)	
WS Q (T=500años)	
Ground	
Bank Sta
